FINAL TECHNICAL REPORT

FRETTING CORROSION IN AIRFRAME RIVETED AND PINNED CONNECTIONS

(Grant No. F49620-93-1-0488)

George T. Hahn and Carol A. Rubin

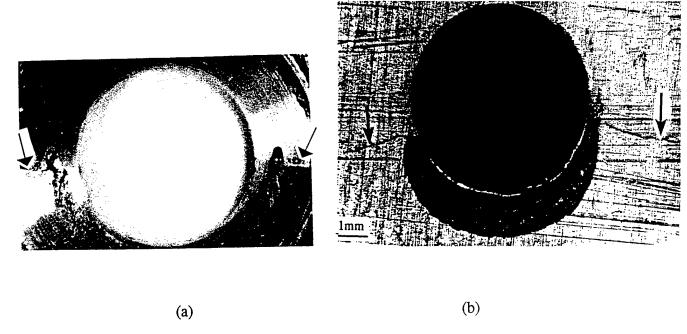
Figure 4. Examples of fretting fatigue at different locations of a single rivet-row lap joint: (a) fretting fatigue at the countersunk rivet shank-panel interface near $\theta = 0^{\circ}$ and $\theta = 180^{\circ}$ (location A in Figure 2), (b) fretting fatigue at the rivet shank-panel interface (location B in Figure 2). Fretting at the rivet shank-panel interface at $\theta = 90^{\circ}$ (location D in Figure 2) produces wear but no fatigue cracks. Arrows point to fretting fatigue cracks.

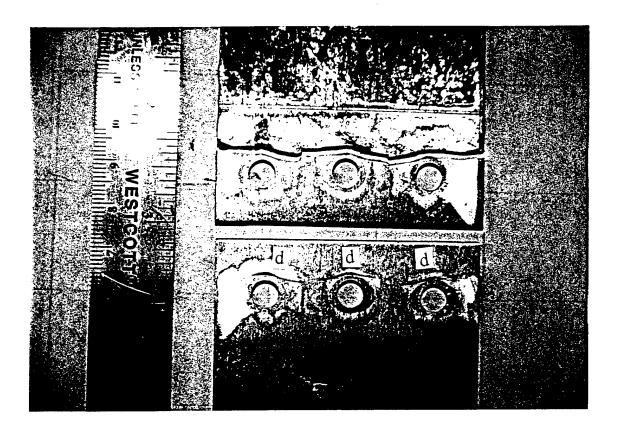
Figure 7 Failure of 3-rivet, 1-rivet-row test sample (sample 2 in Table 1) subjected to cyclic loading with a frequency of 0.1 Hz to a nominal stress of 50 MPa (R=0.1) in 3.5% NaCl with an imposed anodic emf. The sample failed after 26,070 stress cycles compared with > 100,000 cycles for a cathodically protected sample (sample 1 in Table 1). Both samples were assembled with steel fasteners and dislayed the same type of fracture.

Unlike the failures illustrated in Figure 3 where the failure originated at the hole edge of the upper, countersunk panel (refer to Figure 1) of a joint fastened with aluminum rivets, this failure originated remote from the hole in the lower, noncountersunk panel. The failure is believed to be related to the high stresses at the interior surface of the lower panel (see location B in Figure 2), and the effects of the lateral clamping produced by the stiffer, steel fasteners. Fretting wear damage produced by the fracture edge is visible at (d).

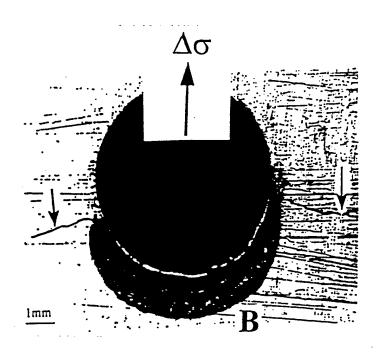
Figure 3. Important fretting fields observed in laboratory tested riveted lap joints.
